Dynamic Inspection of composite to metal bond with air coupled and Squirted UT
A Dhvani Research Application Note

AIR COUPLED NDT OF METAL COMPONENTS

NON-CONTACT WATER COUPLED AND AIR COUPLED NDT SOLUTION

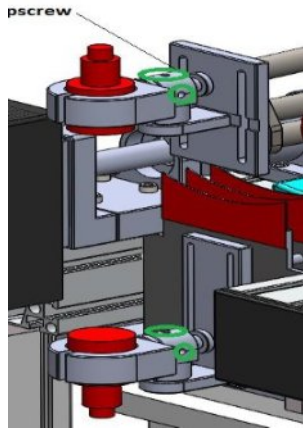
air coupled probes(red)

Both the inspections are carried out at the same time with the air coupled inspection leading the squirted mechanism as the presence of water on the surface may result in variations with the air coupled readings and also any drop of water falling on the

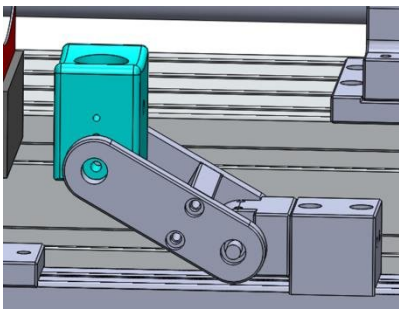
Squirted UT probe (blue)

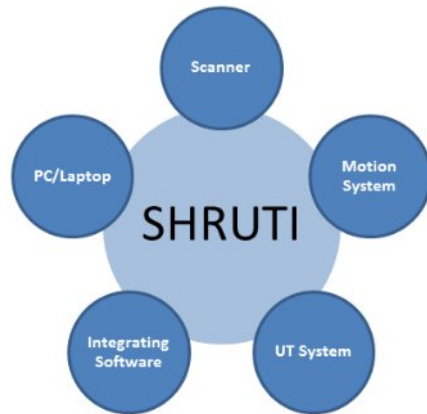
The system employs rugged servo motors for motion requirements and had industrial standard safety interlocks.

SHRUTI[®] offers very high resolution images of the test coupon with very high scanning speeds. The complete instrument control is through the software. Skeleton of the system is being

built from lightweight aluminum extrusions which are upgraded to Stainless Steel for heavy duty applications. All the electrical connections are rugged and properly routed following industrial standards offering very durable and reliable running.

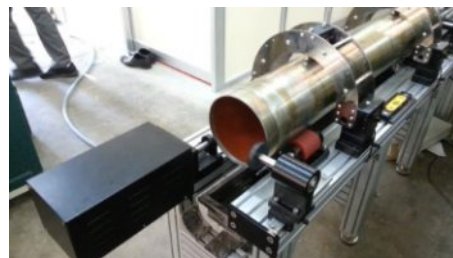
System with sample

The system employs a centralized lubrication system to cater the lubrication requirements, centering rollers, pendent mechanism and auto cycle to reduce human intervention. The system is capable of running 24 x 7 with minimal human intervention. Both the pulser receivers are synchronized and interfaced with a central computer which controls both the pulser receivers and motion hardware at the same

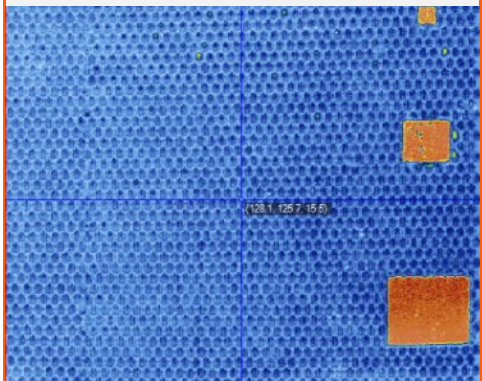
A Typical C Scan Of Honey Comb Structure with defects

Honey comb structure sandwiched between composite face plates are finds very wide applications in all areas below is a C Scan of the same.

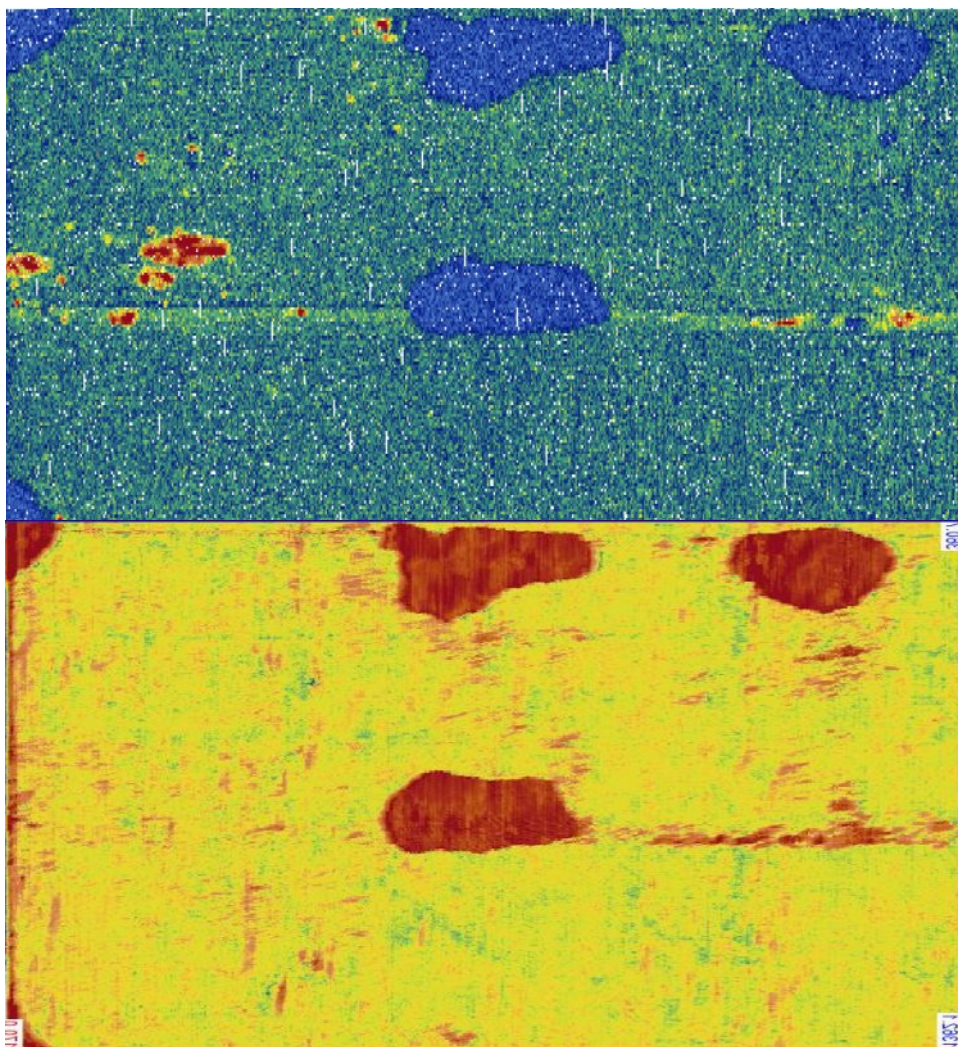
Air coupled and squirted UT C Scan images. The lengthier portion is along the axis and the width is along the circumference
